Service Technical Information

NSX-S111 / S112 / S115 / S116 / S119 / S16 A111 / A115 / XR-H220MD

Coming off of KEY, CASS

REF.No. :G - A0 - 110 - E0

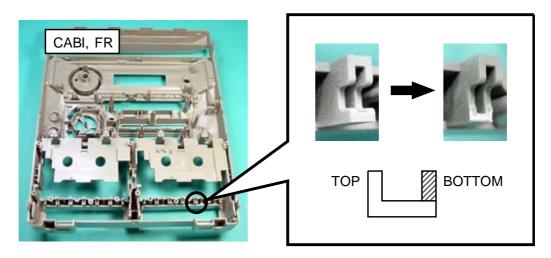
KEY, CASS may come off owing to damage on CABI, FR on the above models. The following countermeasure shall be taken in the event such indication is made.

- 1) Remove HLDR, CASS and KEY, CASS in the deck area of CABI, FR.
- 2) Cut off the bottom portion of the retention section of KEY, CASS of CABI, FR. (Total of 14 locations for DECK1 and 2 combined.)

3) Install HLDR, CASS of the modified item after installing KEY, CASS and fix it with a screw.
